DAVID EVANS
AND ASSOCIATES INC.

COURTHOUSE SQUARE FLOOR DEFLECTIONS 11-24-2008 JGW

Marion County
OREGON
BUSINESS SERVICES
Facilities Management

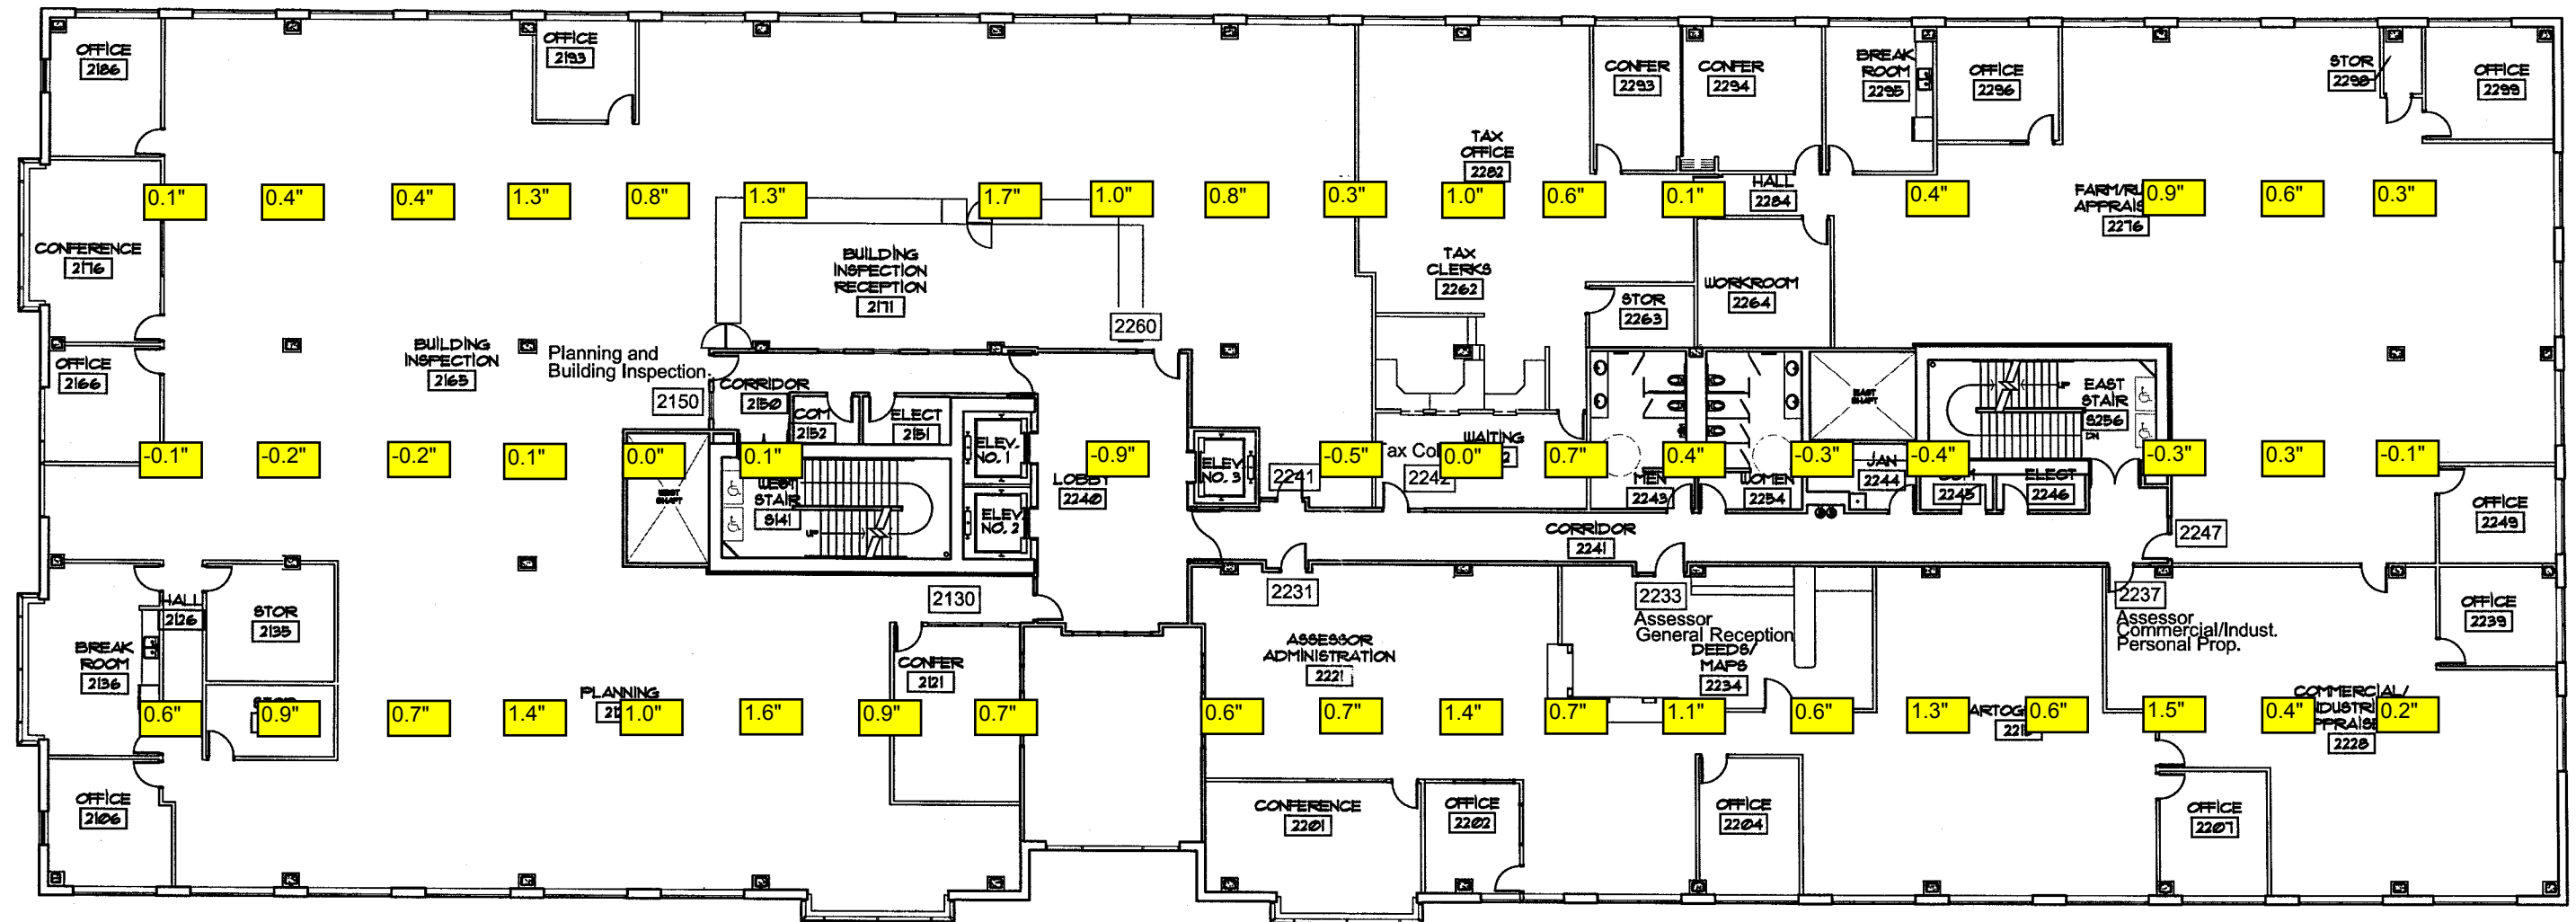
CS-2

1) Survey data is from survey conducted by David Evans and Associates' JKB and DDB (surveyors' initials) from 10-24-2008 to 11-21-2008. The survey was conducted with a water-level manometer.

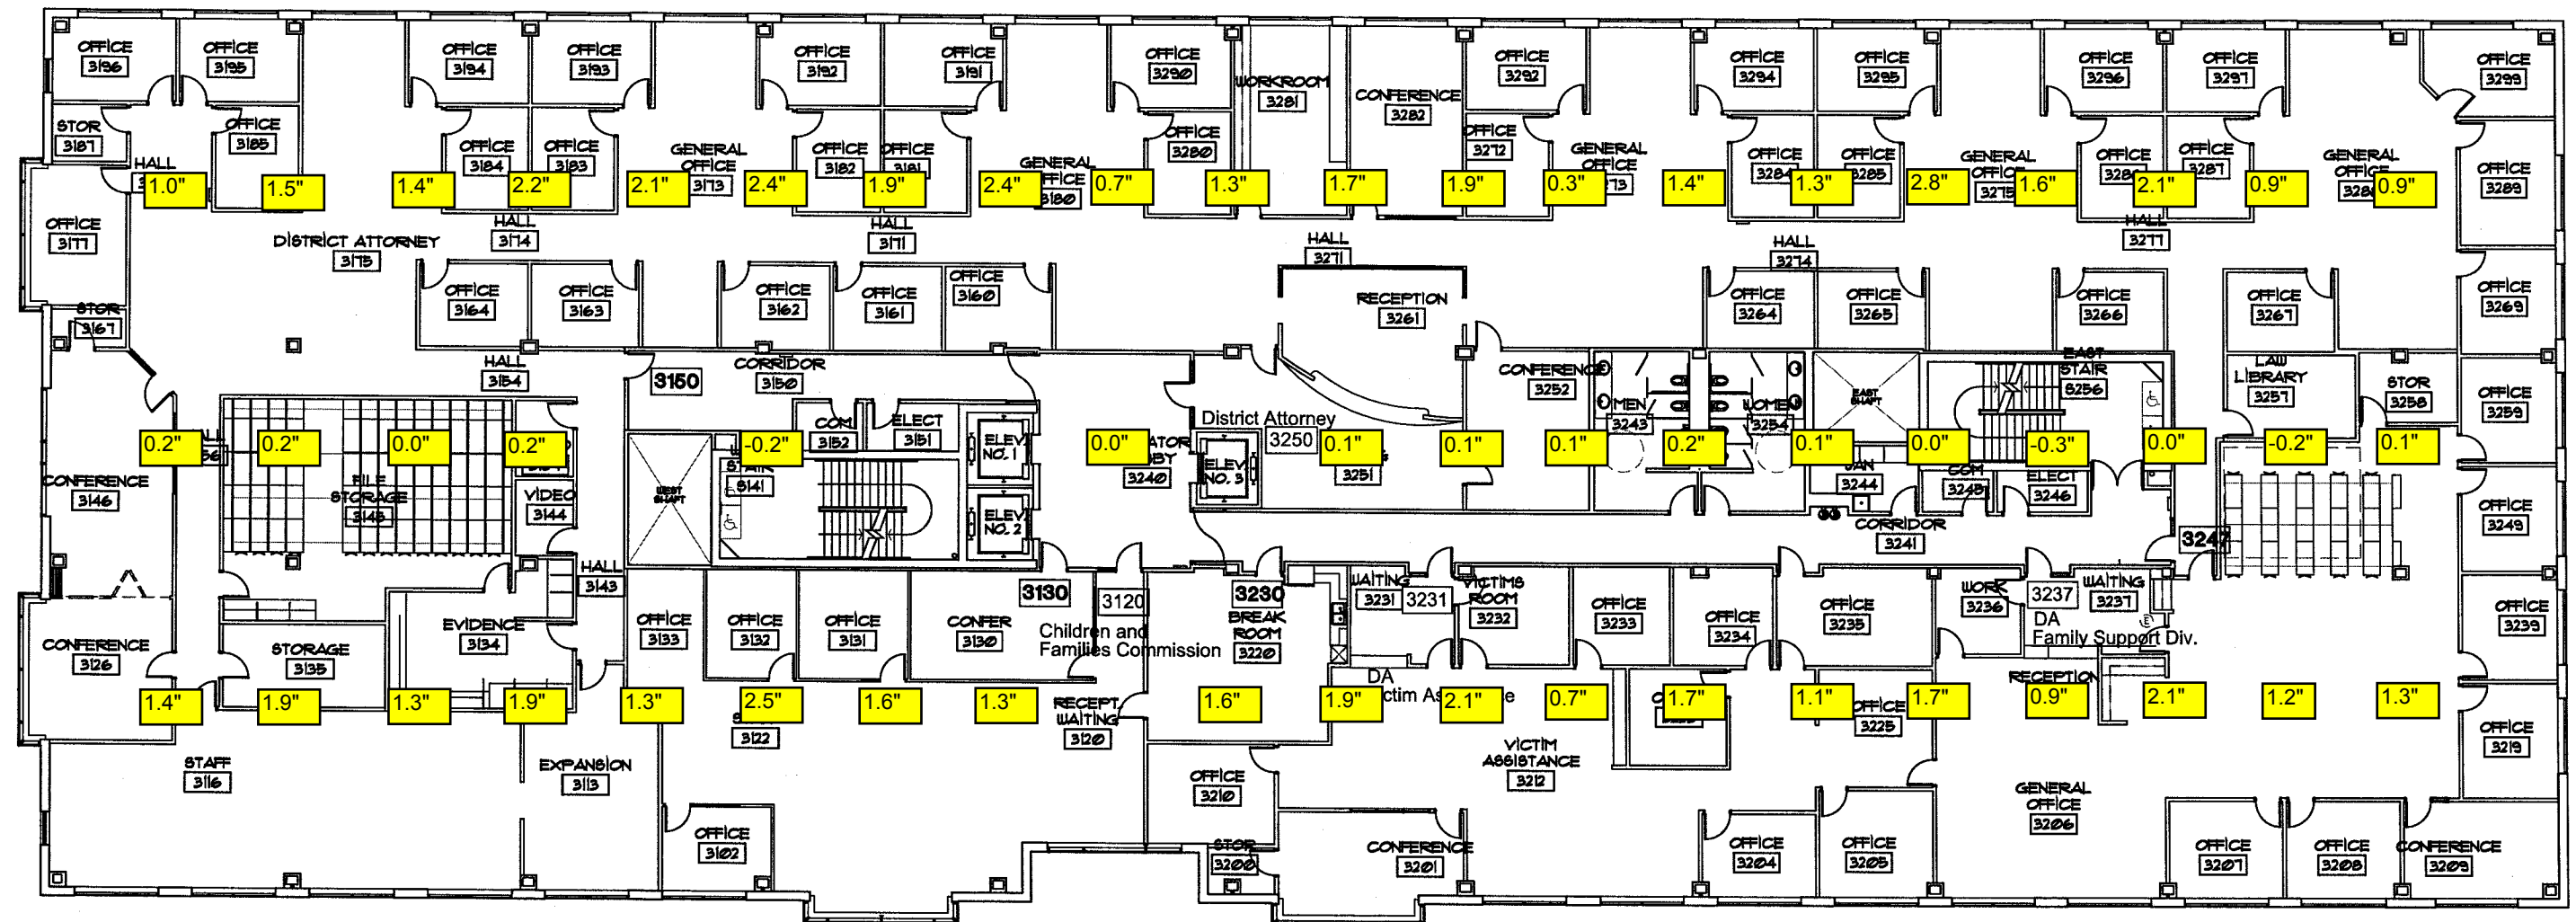
CS-3

1) Survey data is from survey conducted by David Evans and Associates' JKB and DDB (surveyors' initials) from 10-24-2008 to 11-21-2008. The survey was conducted with a water-level manometer.

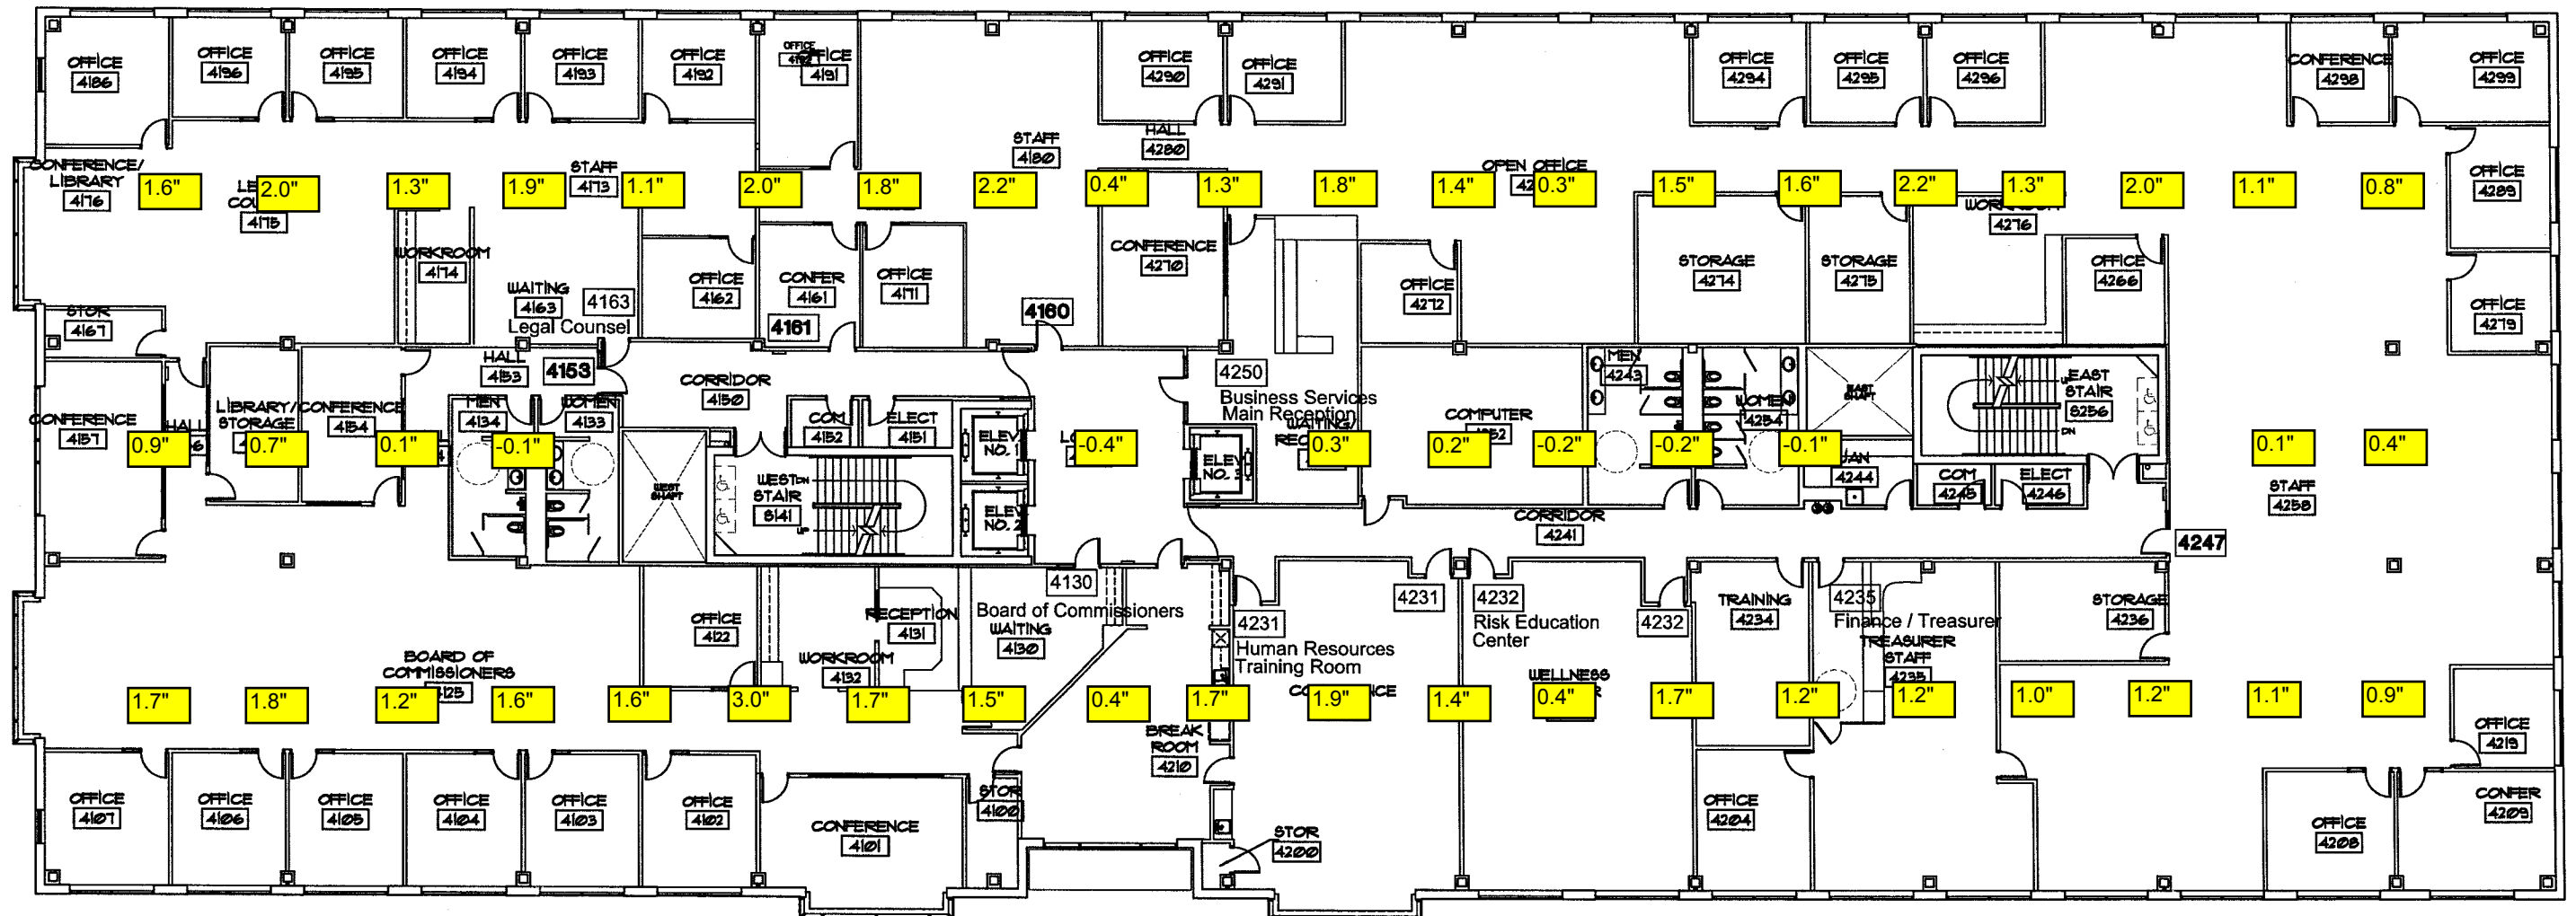
CS-4

1) Survey data is from survey conducted by David Evans and Associates' JKB and DDB (surveyors' initials) from 10-24-2008 to 11-21-2008. The survey was conducted with a water-level manometer.

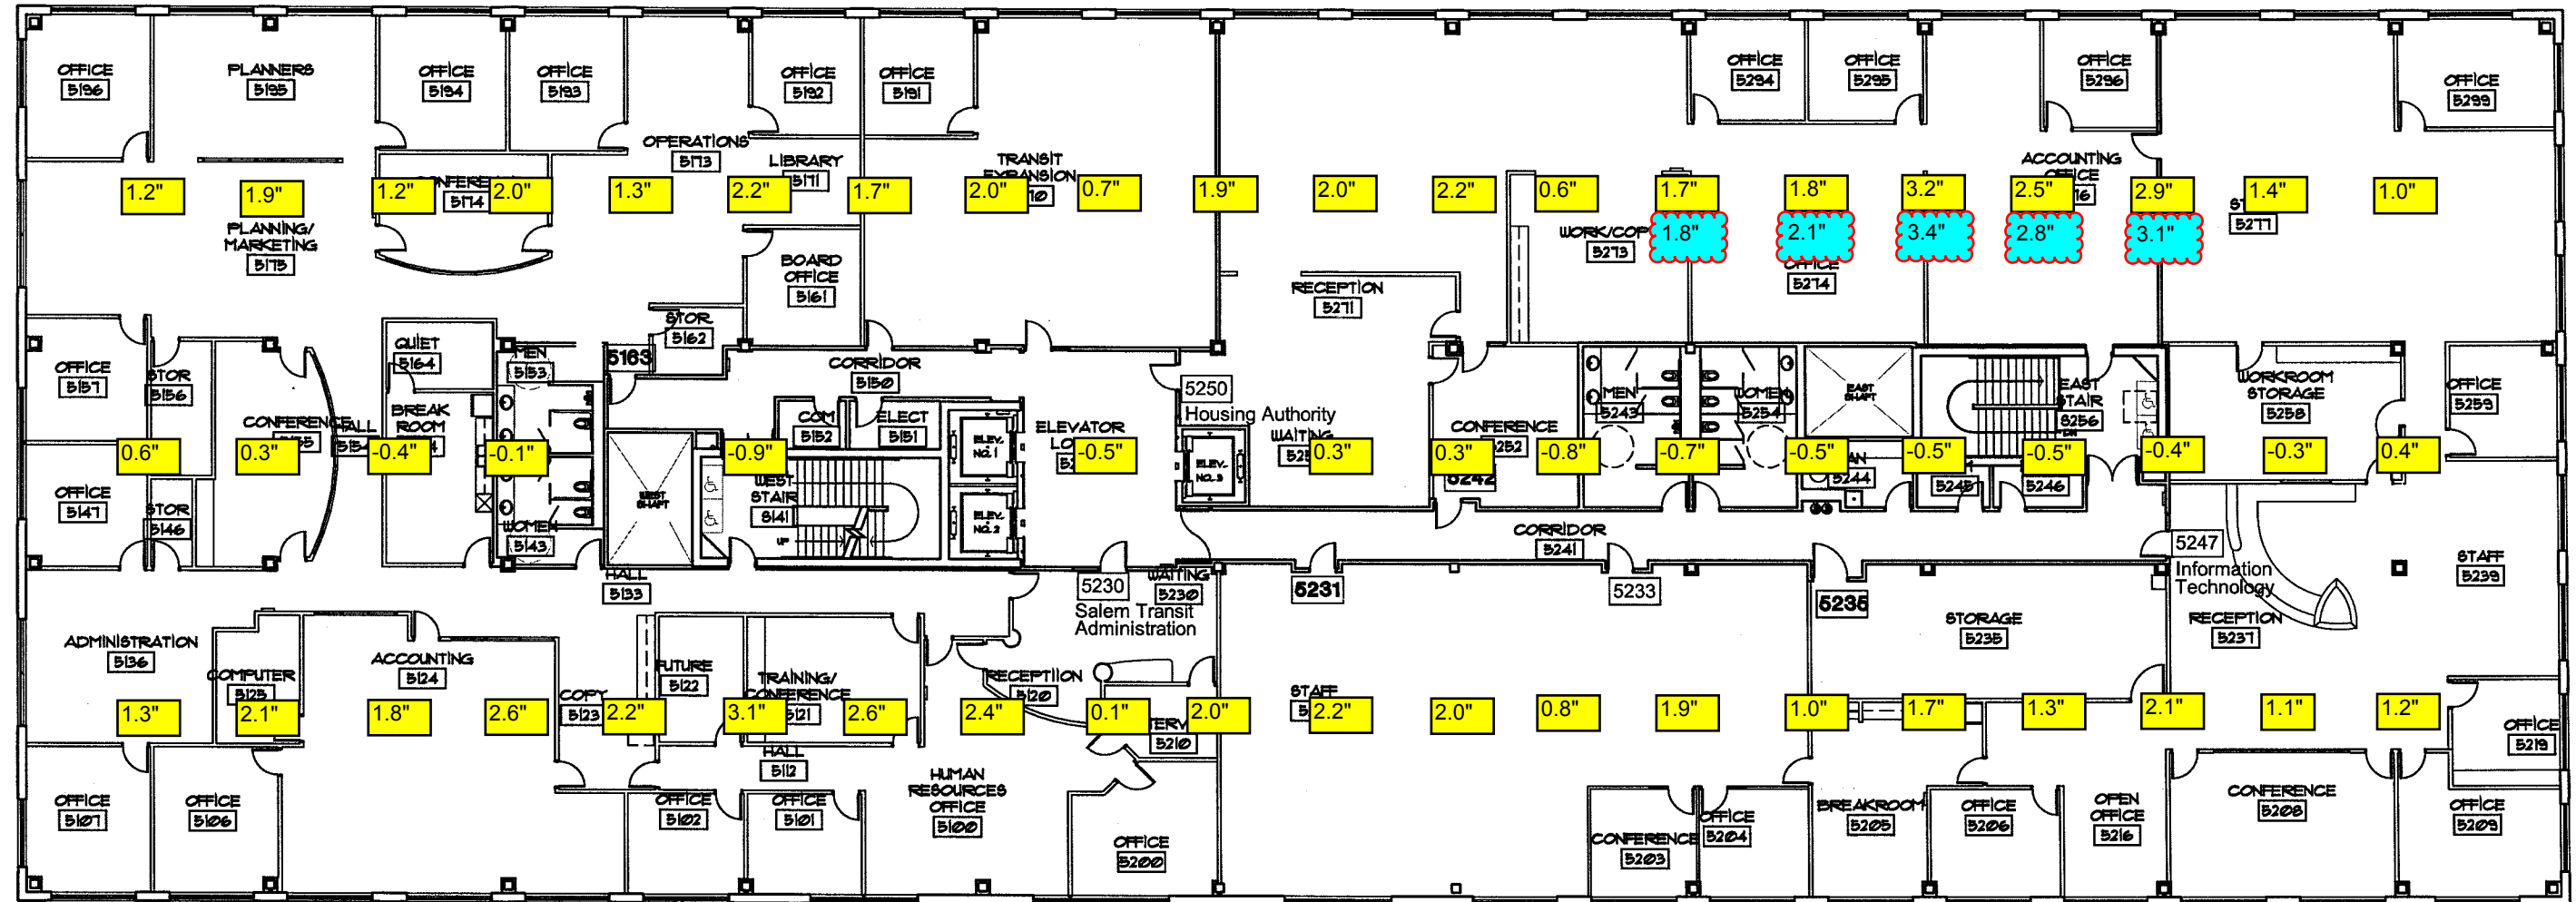
CS-5

1) Survey data is from survey conducted by David Evans and Associates' JKB and DDB (surveyors' initials) from 10-24-2008 to 11-21-2008. The survey was conducted with a water-level manometer.

4) $X.X''$ Indicates measured deflection from survey conducted on 6-06-2007
